DEPARTMENT OF TRANSPORTATION**DIVISION OF ENGINEERING SERVICES**

Contract #: 04-0120F4Cty: SF/ALA Rte: 80 PM: 13.2/13.9File #: 69.15**SOURCE INSPECTION REPORT****Resident Engineer:**Pursell, Gary**Address:** 333 Burma Road**City:** Oakland, CA 94607**Report No:** SIR-001968**Date Inspected:** 26-Mar-2010**Project Name:** SAS Superstructure**OSM Arrival Time:** 700**Prime Contractor:** American Bridge/Fluor Enterprises, a JV**OSM Departure Time:** 1900**Contractor:** Zhenhua Port Machinery Company, Ltd (ZPMC), Changxing Island **Location:** Chang xing Dao, Shanghai**Quality Control Contact:** Mr. Don Walton**Quality Control Present:** Yes No**Material transfer:** Yes No N/A**Sampled Items:** Yes No N/A**Stock Transfer:** Yes No N/A**OK to Cut:** Yes No N/A**Rebar Test Witness:** Yes No N/A**Delayed/Cancelled:** Yes No N/A**Other:** Coating Inspection**Bridge No:** 34-0006**Component:** See below**Bid Item:** 77, 78, 79**Lot No:** B #204**Summary of Items Observed:**

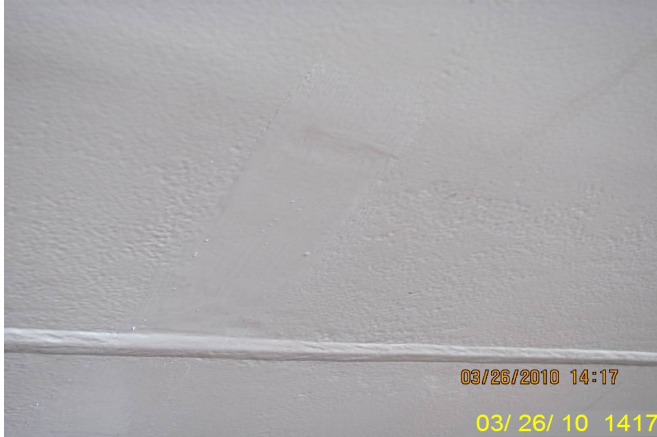
1. An inspection was requested on the OBG external surfaces L6E for final acceptance, vide request no. 3013 at Ship no. 17. This Caltrans inspector observed, ABF inspectors Mr. Wei and Mr. Stone performing DFT check on external surfaces. the DFT was found less than required at few places on the cross beam side. Final touch ups were made on those areas to increase DFT. (Photo attached). But it was not ready for inspection as Curing is required. The opposite side of Cross beam, i.e. Suspender bracket side was rejected by Mr. Aaron prichlik of Caltrans due to the requirement of paint damaged areas.(Photograph of surface damage areas is attached) International protective coatings technical service representative Mr. Li peng was found present during the course of this inspection process.
